# **Selected Images of the Effects of the October 15, 2006, Kīholo Bay-Māhukona, Hawai‘i, Earthquakes and Recovery Efforts**

Data Series 506

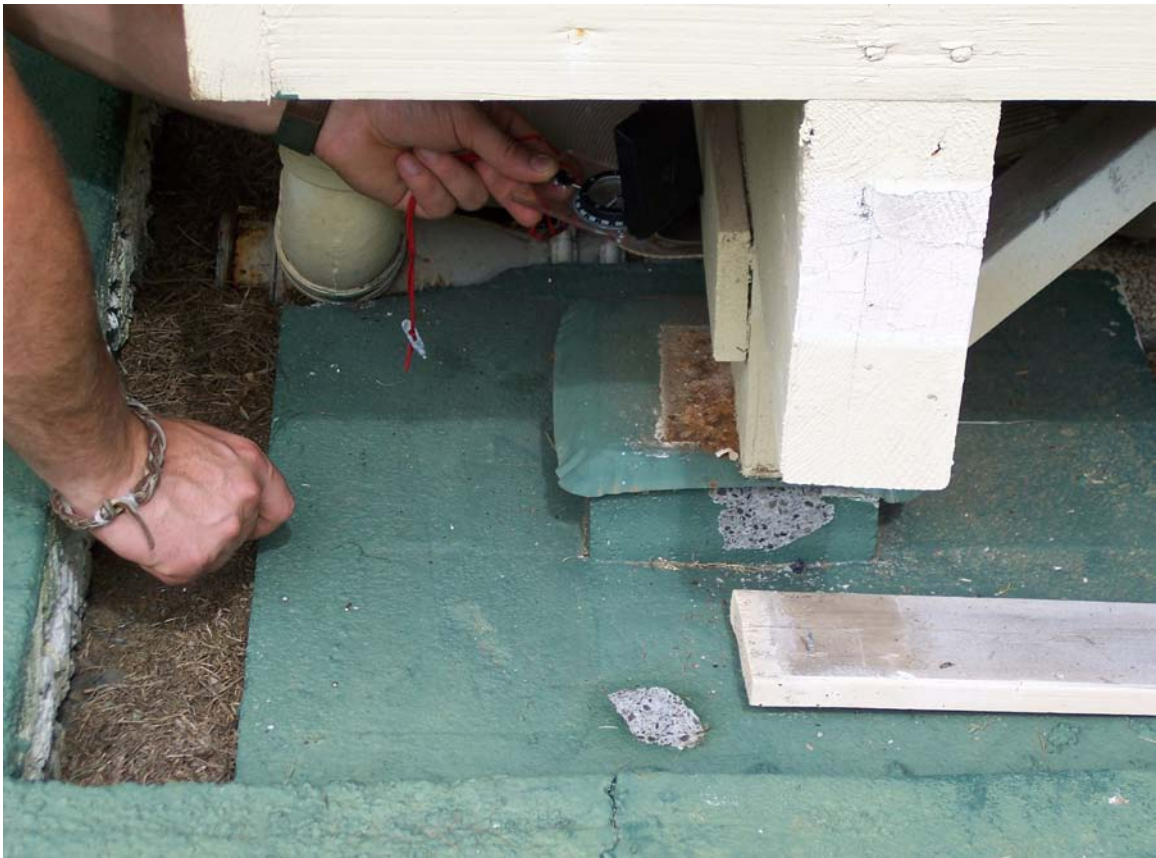
3.12. The earthquake caused offsets of the parish hall's posts from its piers. View of HVO volunteer measuring the extent and direction of pier displacement, 7.62 cm (3 in.) to the northwest. The posts were repositioned and bolted down to the piers. USGS photo by T.J. Takahashi, 10/20/2006 (tjt1208).

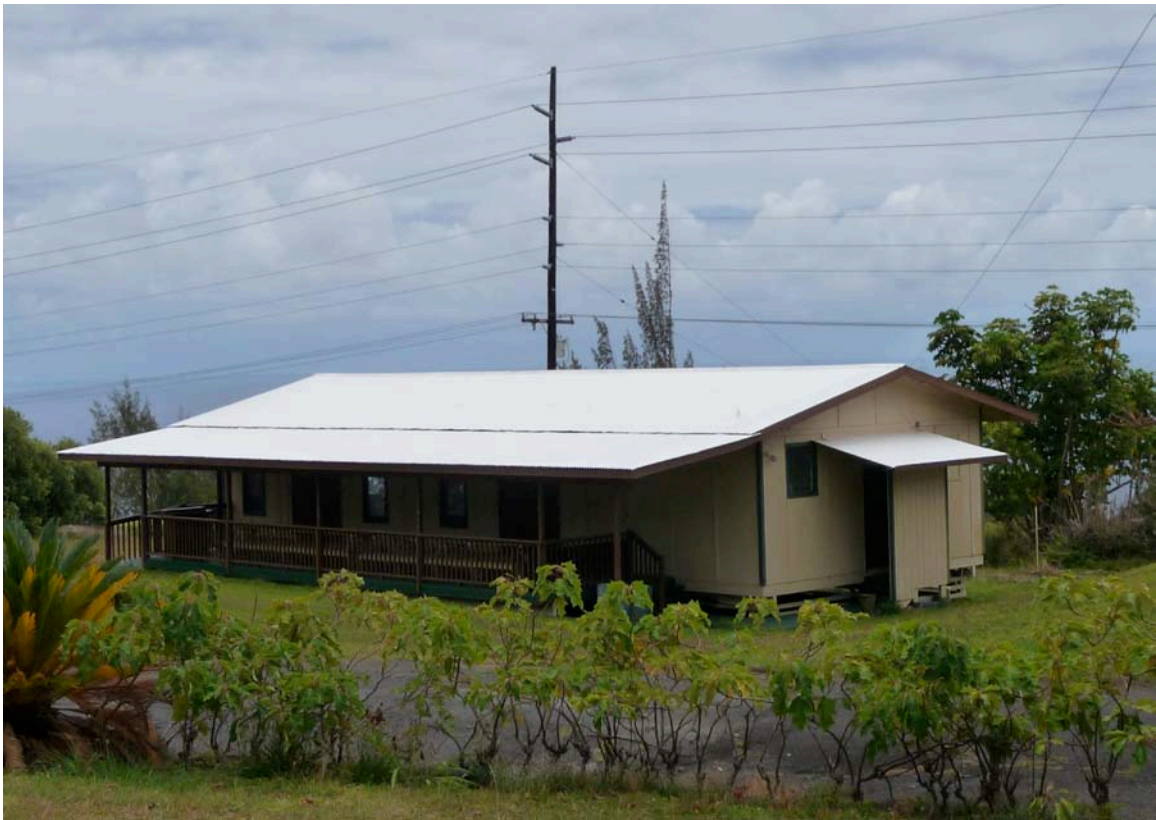
3.13. *Overview image:* The parish hall as it appeared nearly two years after the earthquake, repaired and still in use for classes and social gatherings (view to the north). USGS photo by N.A. Ikeda 6/25/2008 (nai293).

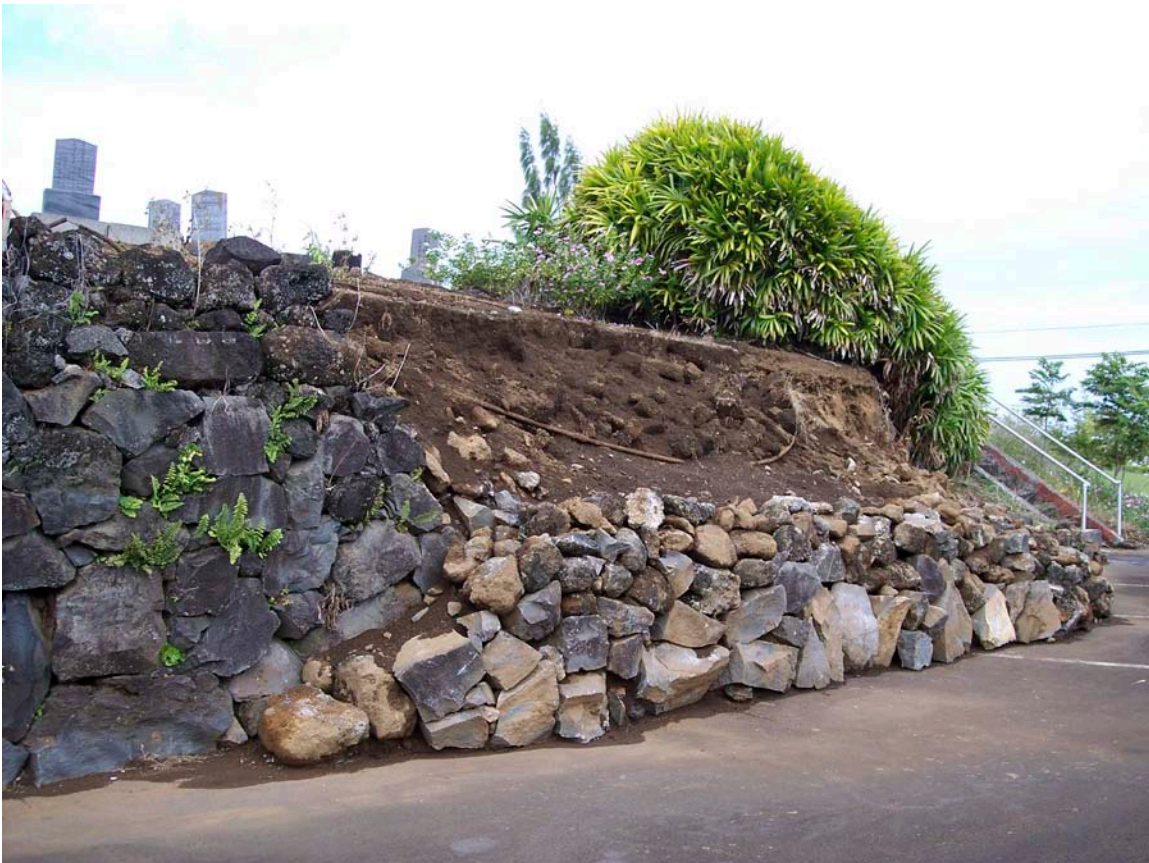
4.1. View of the cemetery's partially restored stacked-rock retaining wall, which collapsed during the earthquake. Displaced rocks were used to hold back the soil (view to the west-northwest). USGS photo by T.J. Takahashi, 10/20/2006 (tjt1237).

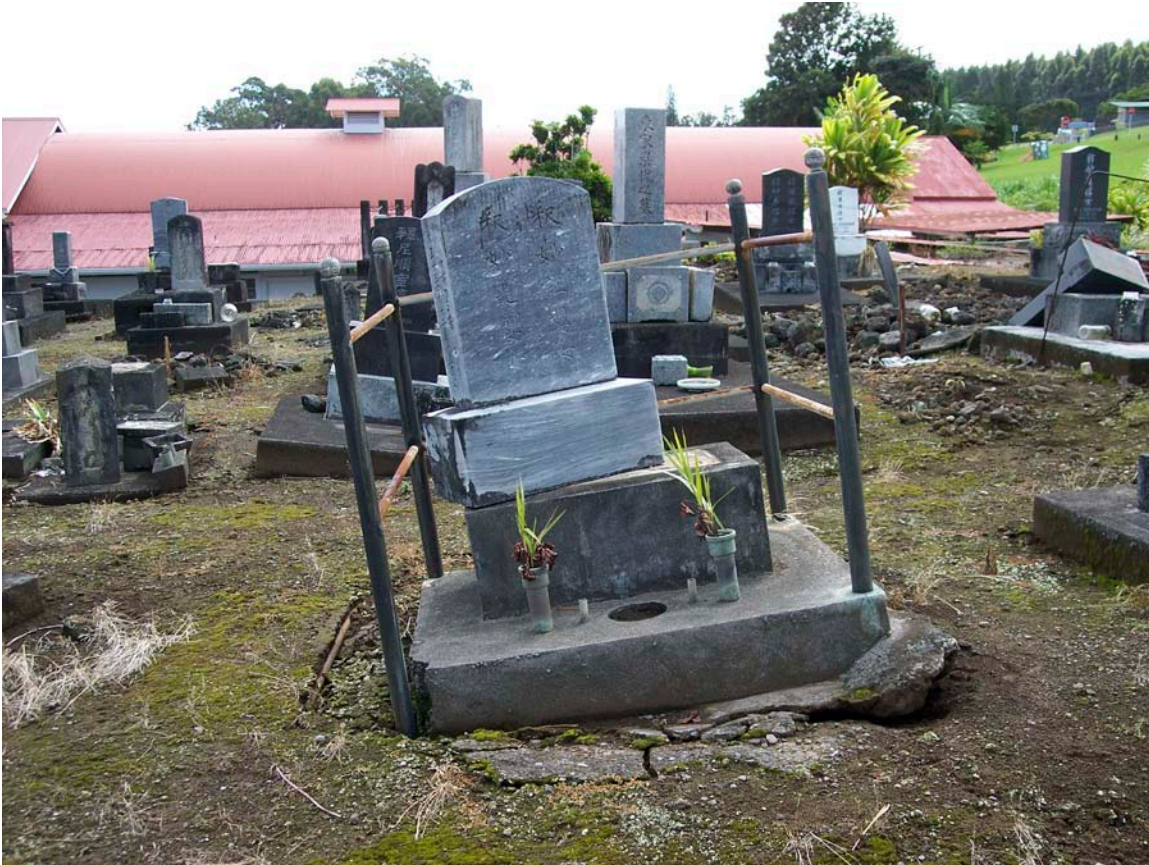
4.2. View of a headstone—which partially slipped off its base and rotated counter-clockwise—sitting precariously atop a slab, which is tilting from ground-settling. Other headstones in the cemetery (as in the background of the photo) suffered a similar fate (view to the east-southeast). USGS photo by T.J. Takahashi, 10/20/2006 (tjt1268).

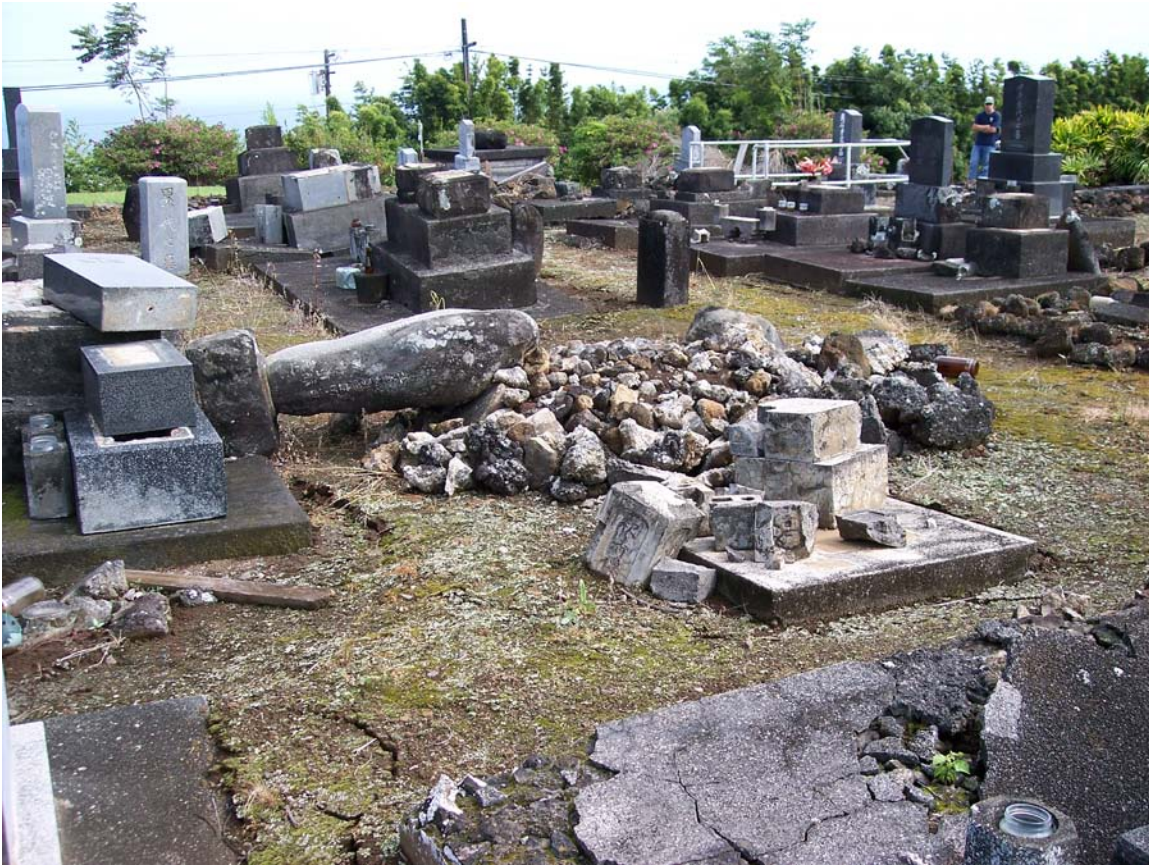
4.3. View of rubble from toppled and broken tombstones in the cemetery. In numerous places, ground-settling caused bases of tombstones to tilt and headstones to topple over in every direction (view to the northeast). USGS photo by T.J. Takahashi, 10/20/2006 (tjt1274).

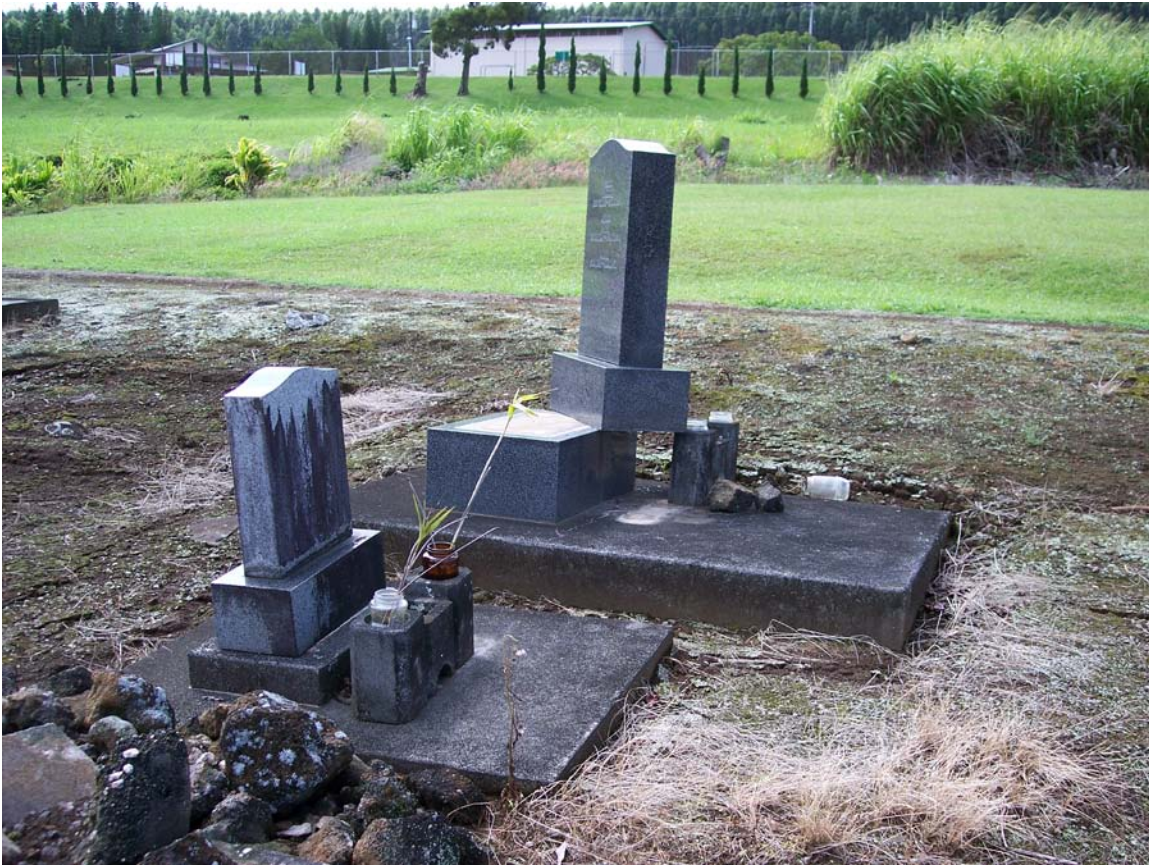
4.4. View of subsidence (to the southwest) in the slab base of a gravesite and the counter-clockwise rotation of its tilted headstone, balanced between the granite block and the offset concrete vase (view to the south). USGS photo by T.J. Takahashi, 10/20/2006 (tjt1272).

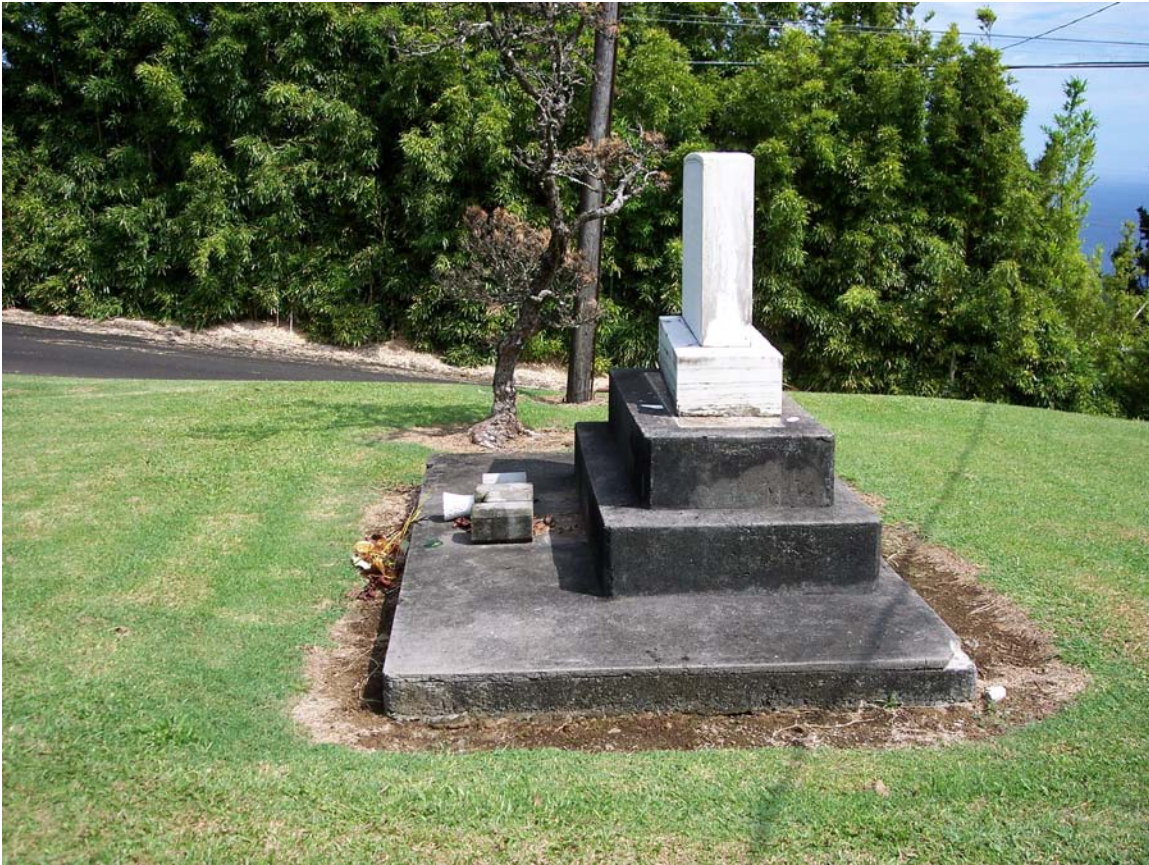
4.5. View of the headstone of a large gravesite—which rotated in a clockwise direction—and its concrete vase, which toppled over (view to the west-northwest). USGS photo by T.J. Takahashi, 10/20/2006 (tjt1287).

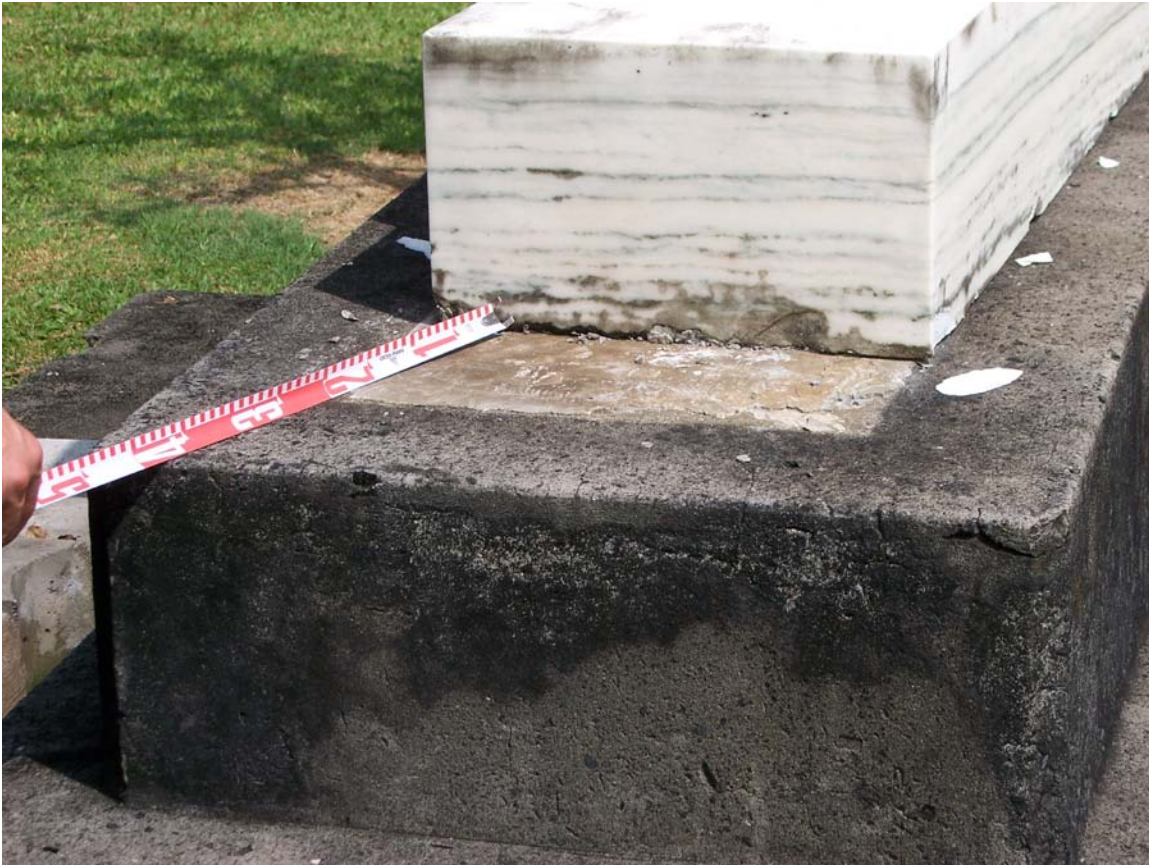
4.6. View of HVO volunteer measuring horizontal displacement—approximately 0.2 m (8 in.) to the northeast—of the marble headstone from its base (view to the northeast). USGS photo by T.J. Takahashi, 10/20/2006 (tjt1288).

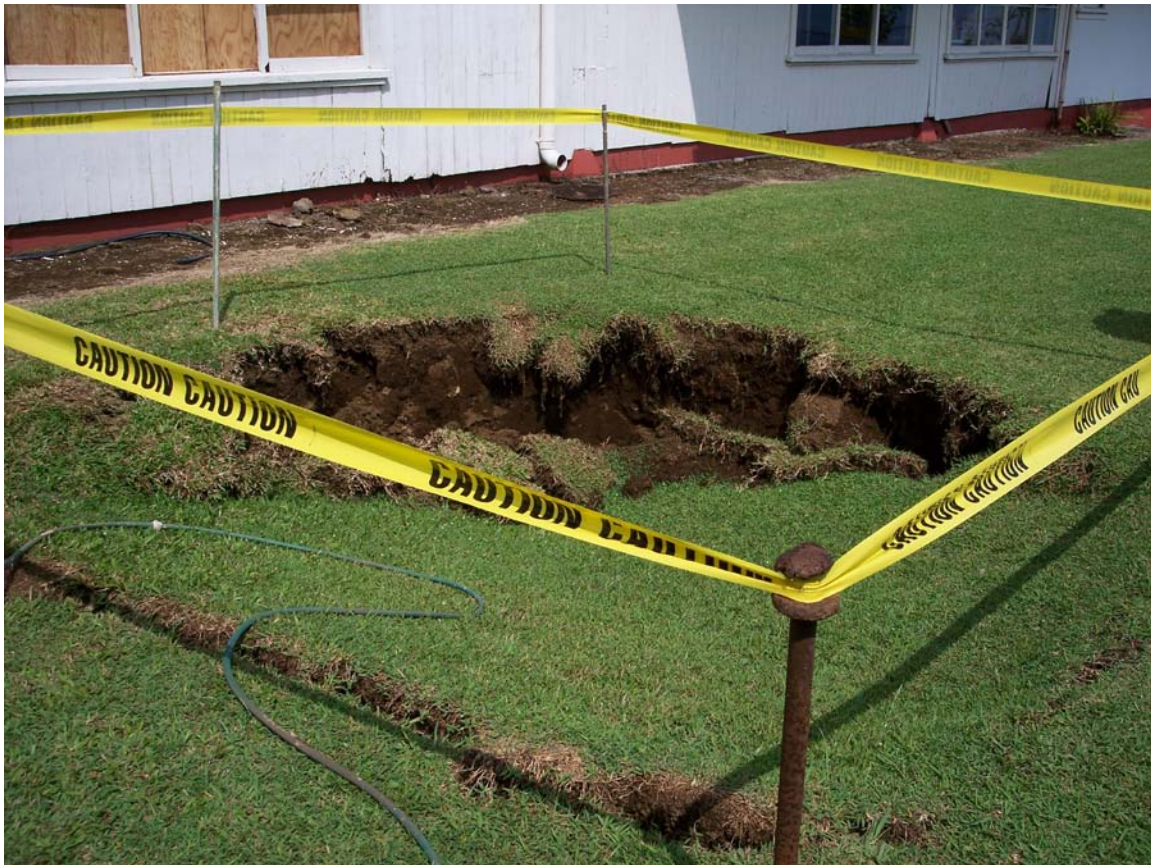
4.7. View of subsidence of the temple grounds, caused by the collapsed cap of a cesspool built over a lava tube (view to the northwest) (R. Matsumoto, oral commun., 1/17/09). USGS photo by T.J. Takahashi, 10/20/2006 (tjt1293).

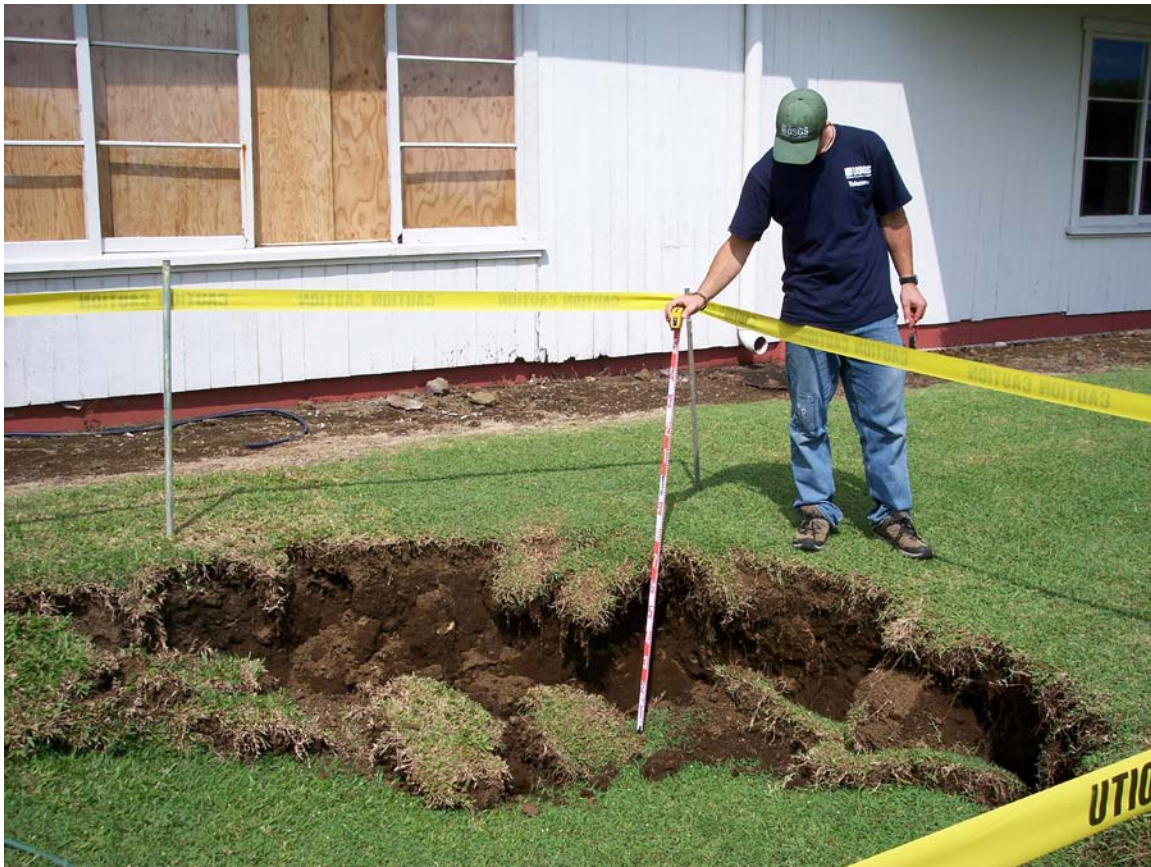
4.8. View of a collapsed pit, showing about 0.7 m (2.3 ft) of ground subsidence. Bowed-out wall in the background (beneath windows temporarily fitted with plywood), which nearly moved off its base, was torn down subsequently and rebuilt (R. Matsumoto, oral commun., 1/17/09) (view to the northwest). USGS photo by T.J. Takahashi, 10/20/2006 (tjt1292).

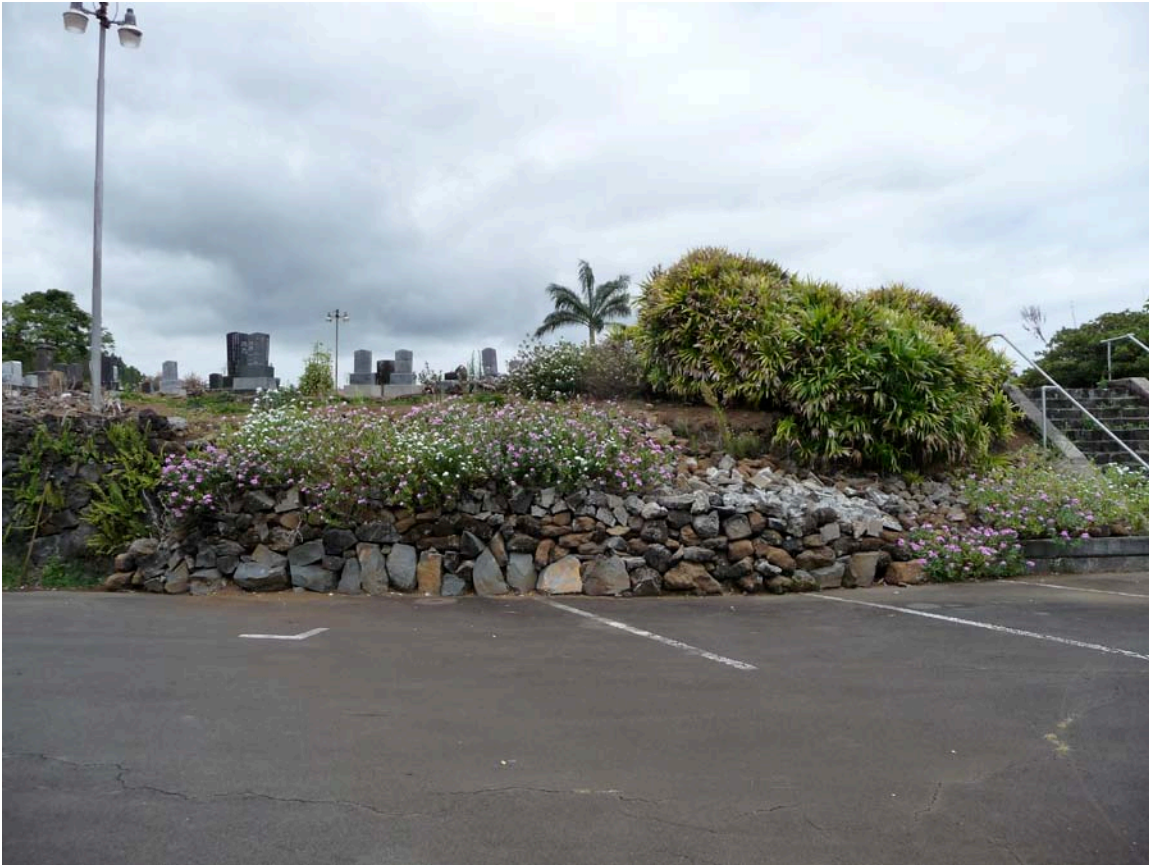
4.9. *Overview image:* The rock wall adjoining the parking lot could not be restored to its former state, but the soil is held in place by the stacked-rock retaining wall and by a ground cover of flowering plants (view to the west-northwest). USGS photo by N.A. Ikeda, 6/25/2008 (nai294).

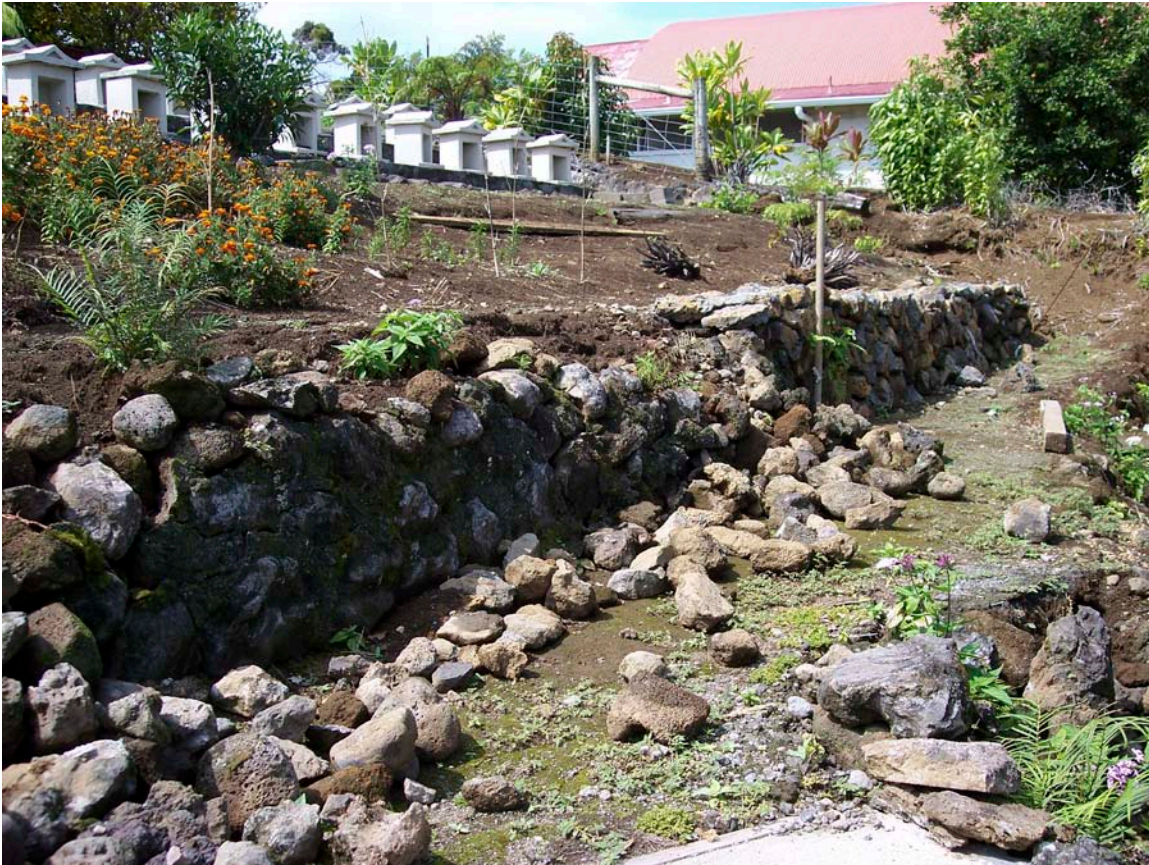
5.2. View of the collapsed stacked-rock retaining wall of the garden, which fronts the rows of shrines located on the slope above it (view to the southwest). USGS photo by T.J. Takahashi, 10/20/2006 (tjt1294).

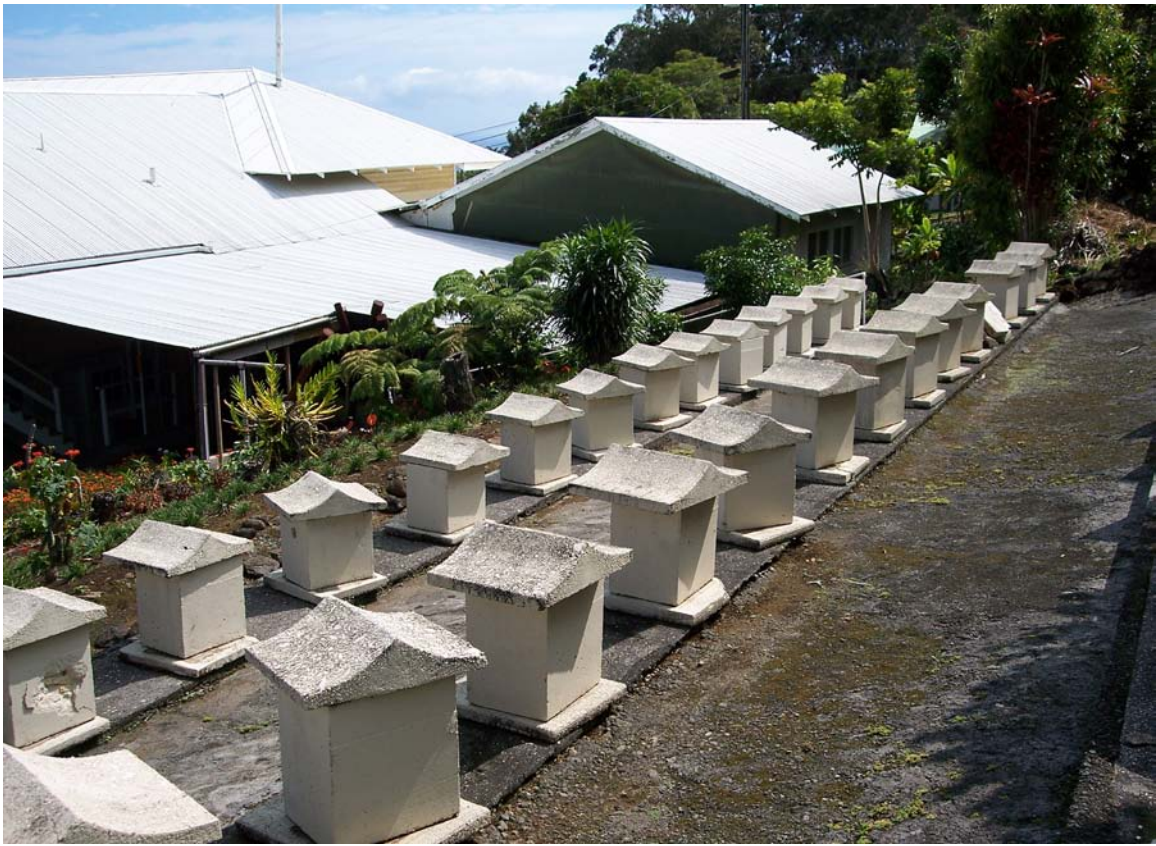
5.3. View of concrete-block shrines (some rotated clockwise), offset from their bases (view to the northeast). USGS photo by T.J. Takahashi, 10/20/2006 (tjt1296).

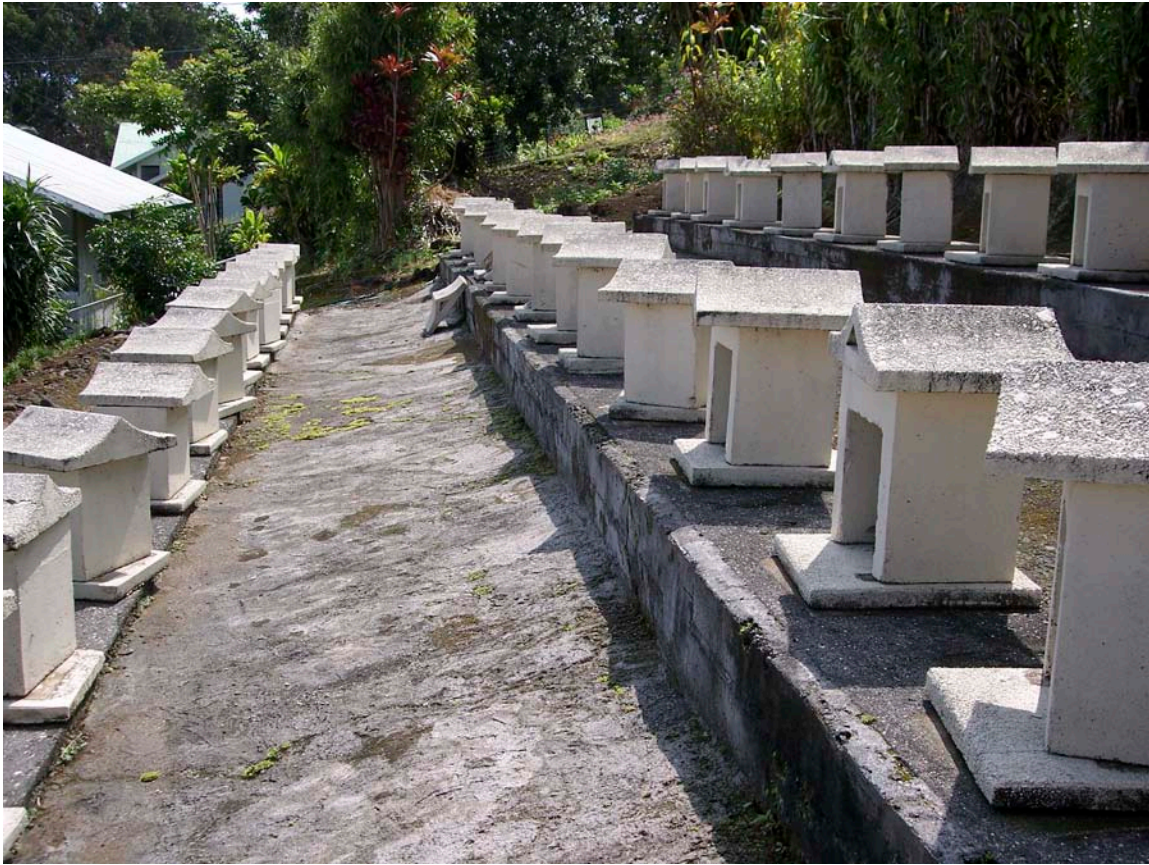
5.4. View from the northwest side of the garden shows some toppled shrines and the clockwise angle of rotation (view to the southeast). USGS photo by T.J. Takahashi, 10/20/2006 (tjt1299).

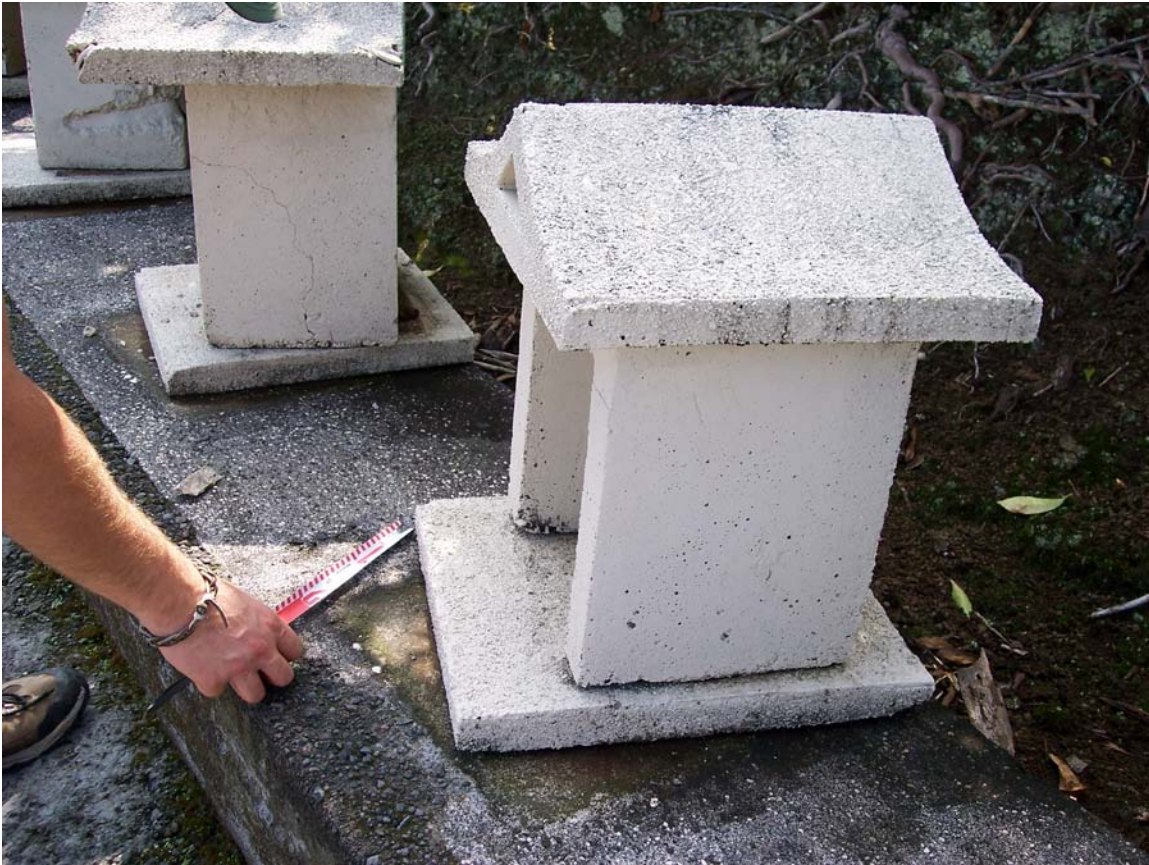
5.5. View of HVO volunteer measuring about 0.2 m (8 in.) of clockwise displacement of a shrine (view to the southeast). USGS photo by T.J. Takahashi, 10/20/2006 (tjt1302).

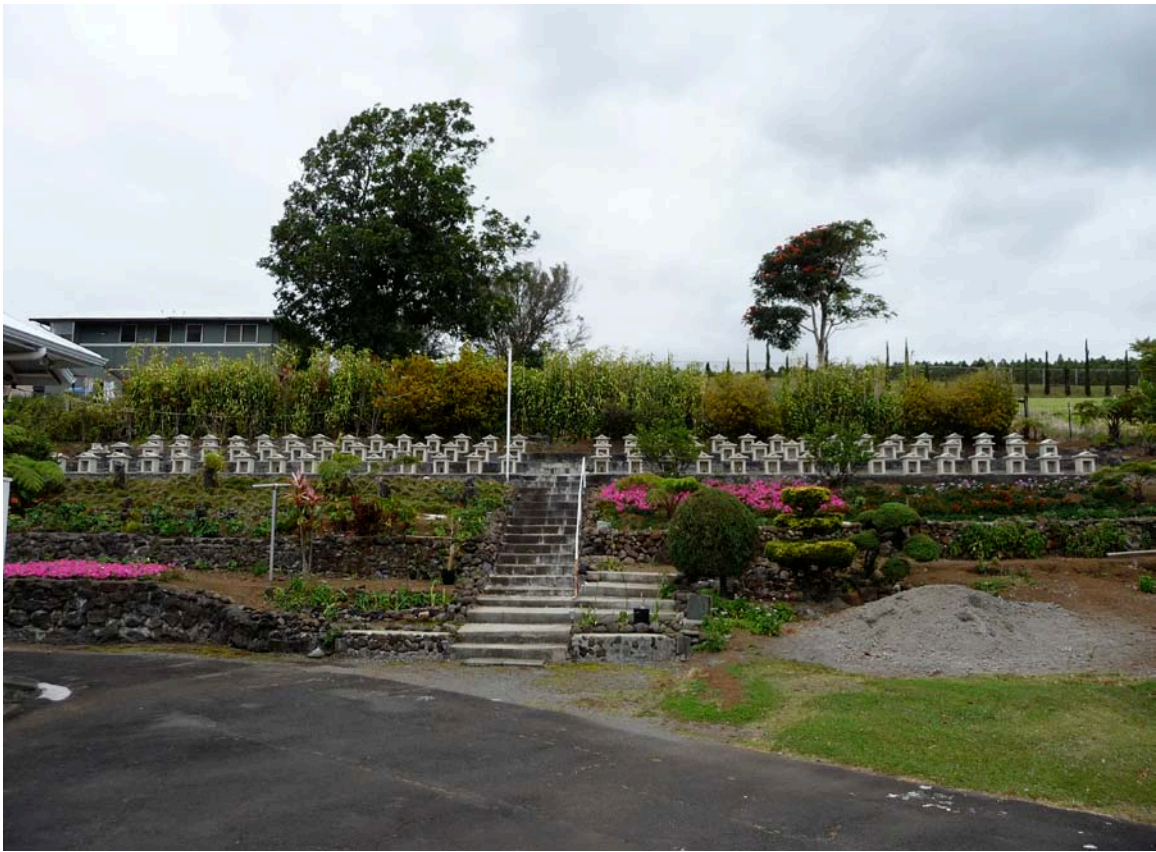
5.6. *Overview image*: Restored shrines stand upright, facing forward again (view to the southwest). USGS photo by N.A. Ikeda, 6/25/2008 (nai296).

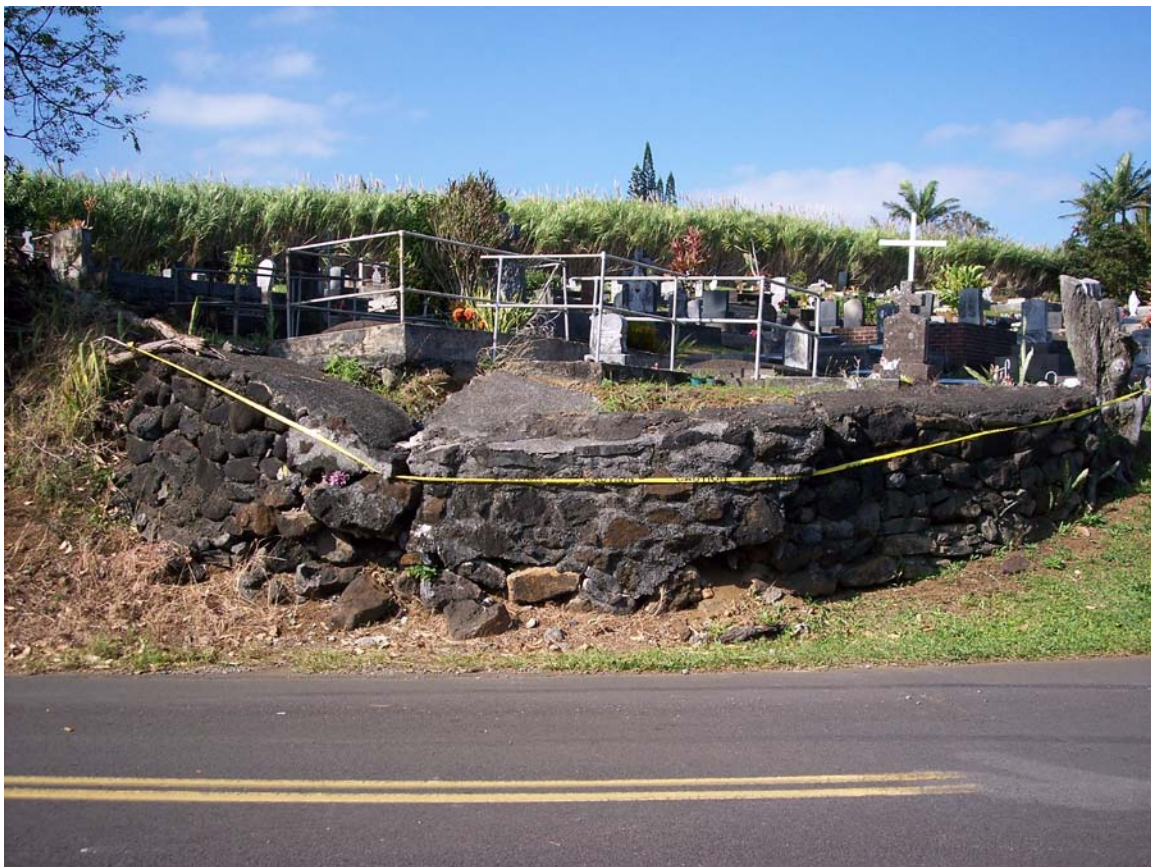
6.1. View of the collapsed rock retaining wall of Kalōpā Cemetery, yellow-tagged for restricted use (view to the southwest). USGS photo by T.J. Takahashi, 2/4/2007 (tjt2378).

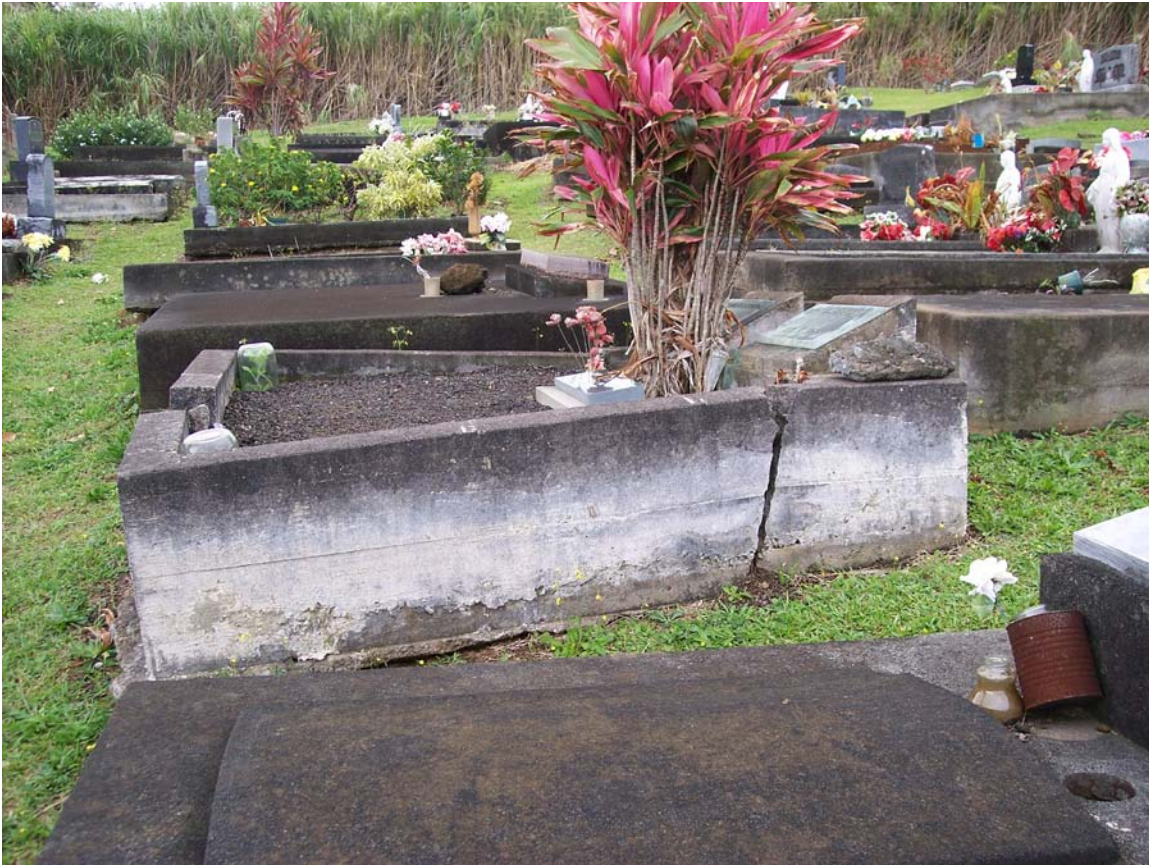
6.2. View of ground slumping that caused offset and cracking of the concrete enclosure of a gravesite (view to the south). USGS photo by T.J. Takahashi, 2/4/2007 (tjt2441).

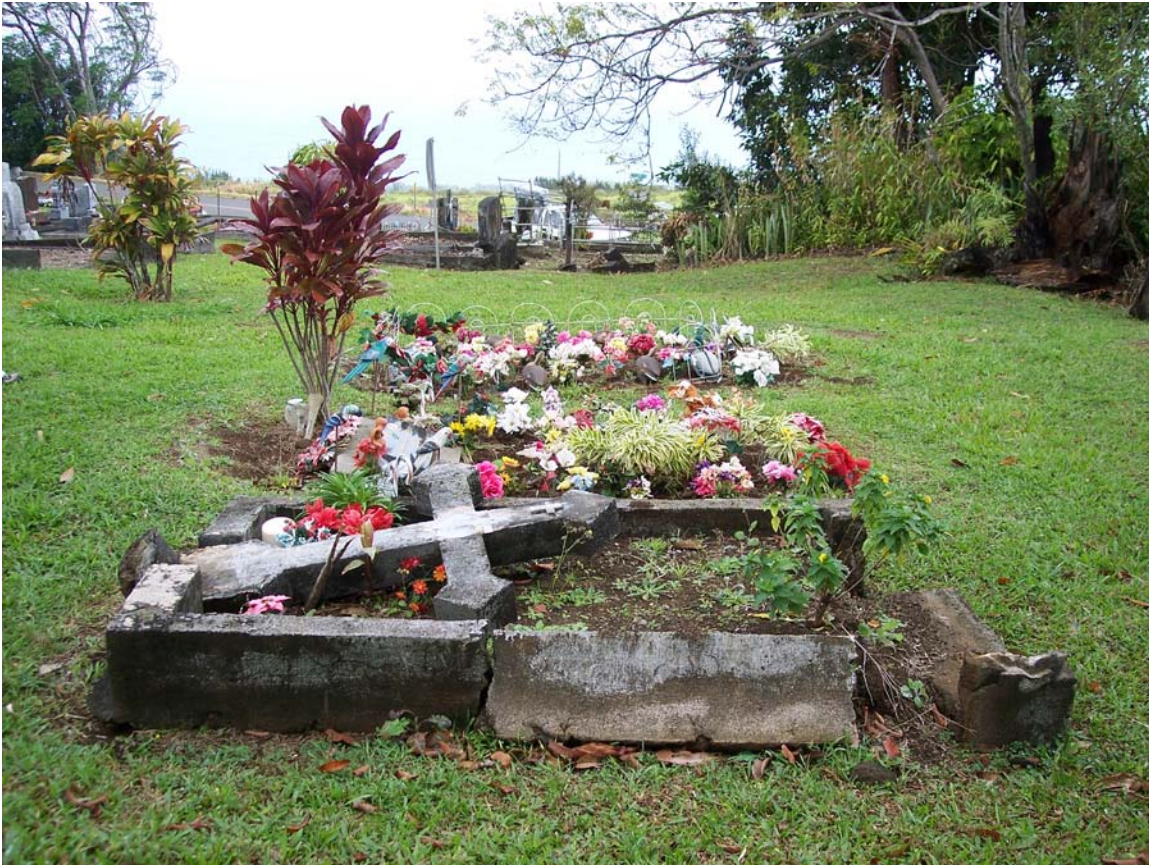
6.3. View of a concrete cross, fallen onto the collapsed concrete border around a gravesite (view to the northeast). USGS photo by T.J. Takahashi, 2/4/2007 (tjt2453).

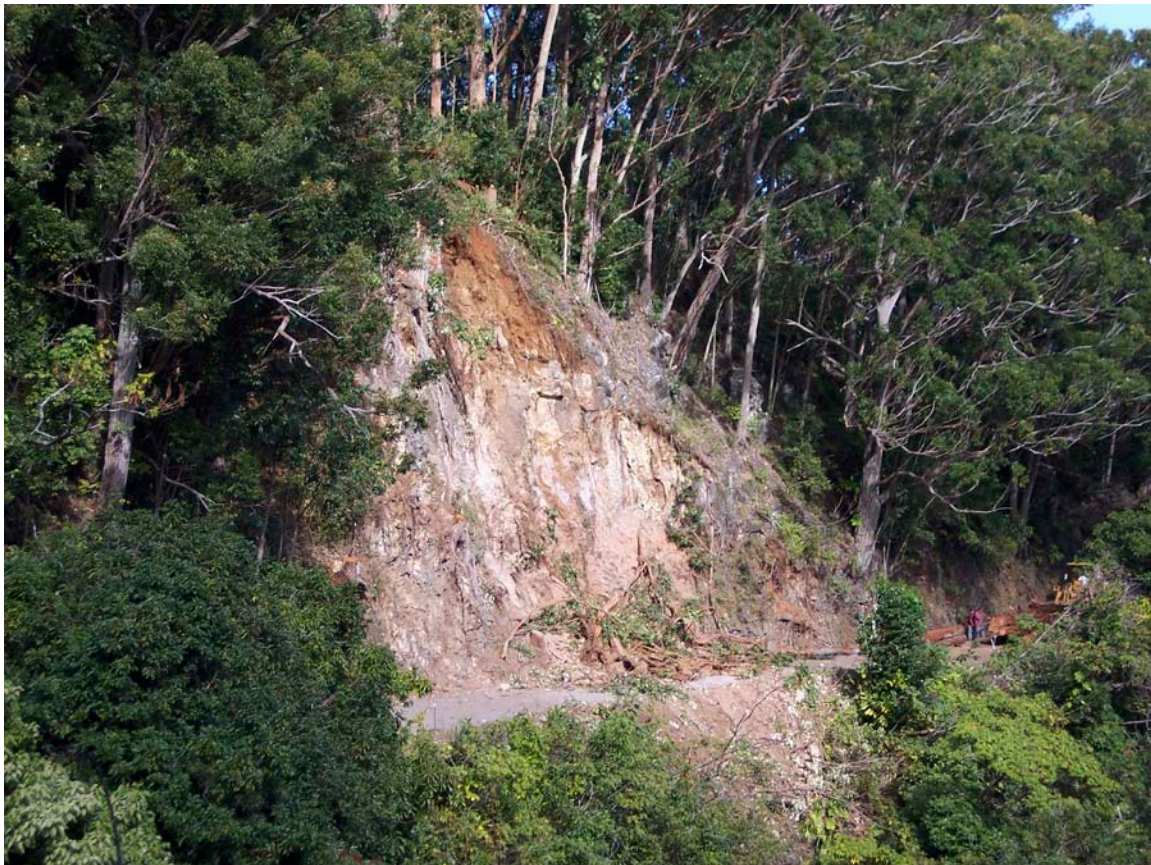
7.1. View of large soil and rock-fall scar—the aftermath of uprooted trees and loosened material—on a cliffside along Sand Gulch Road (view to the northwest). USGS photo by T.J. Takahashi, 12/22/2006 (tjt2210).

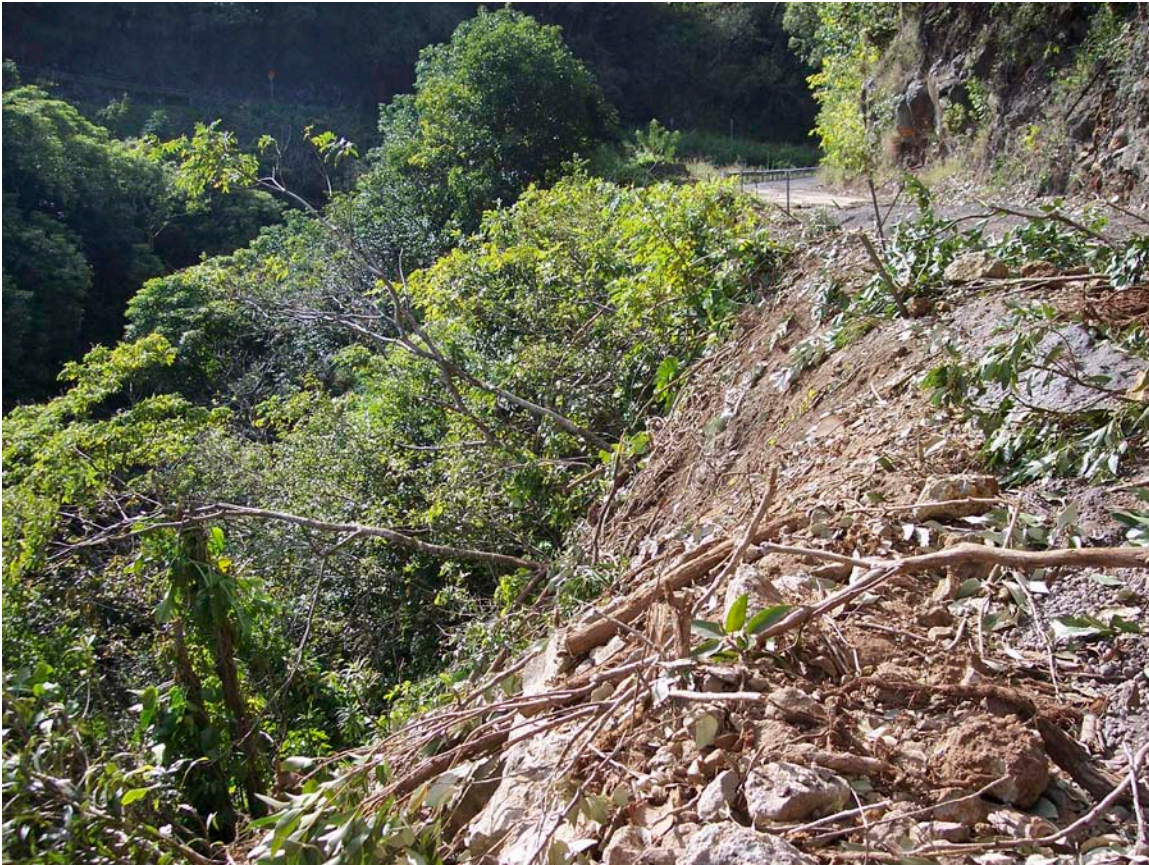
7.3. View of damage to the slope, and of the rocks, soil, and debris shaken loose by the earthquake or deposited into the ravine below (view to the south). USGS photo by T.J. Takahashi, 12/22/2006 (tjt2185).

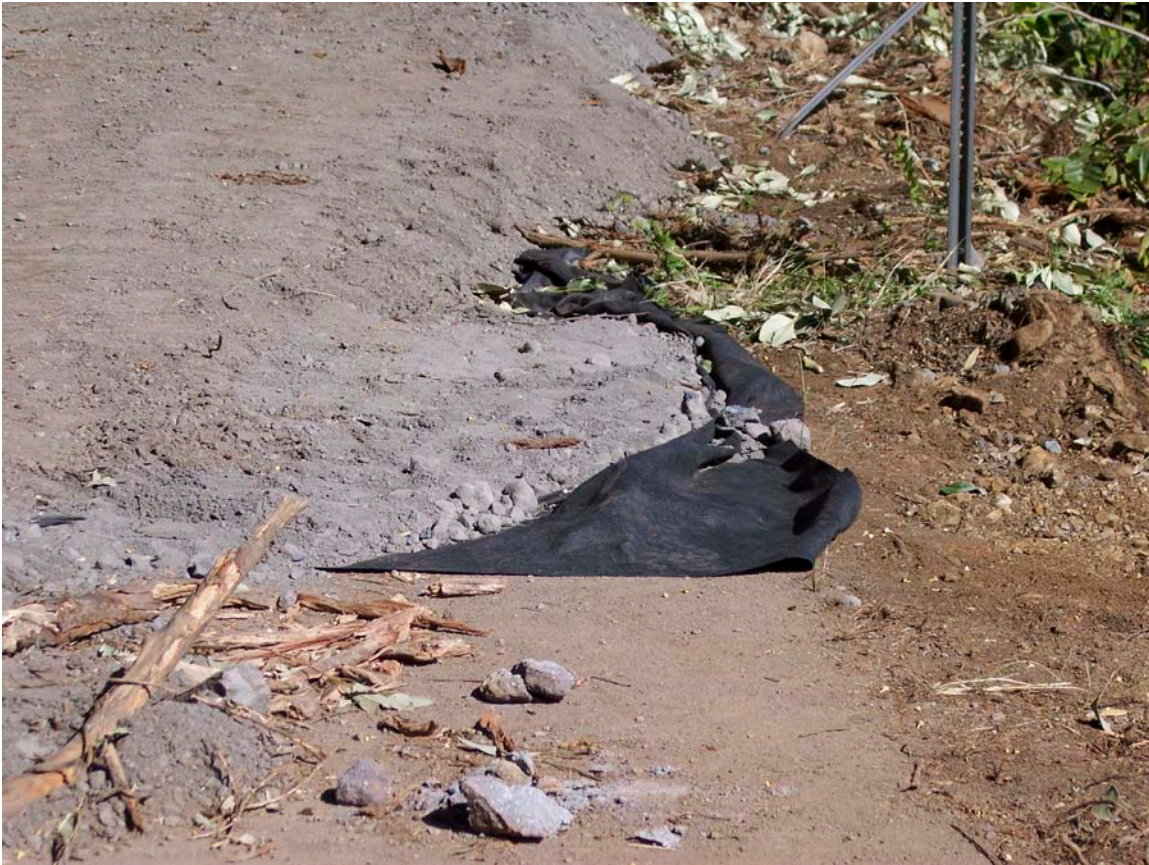
7.4. View of a thick layer of fine gravel covering a geohazard fabric to soften the fall of trees cut down to prevent further damage to the cracked road (view to the north). USGS photo by T.J. Takahashi, 12/22/2006 (tjt2230).
